PASSAIC RIVER BASIN

POINT VIEW DAM

PHASE I INSPECTION REPORT

JULY 1978

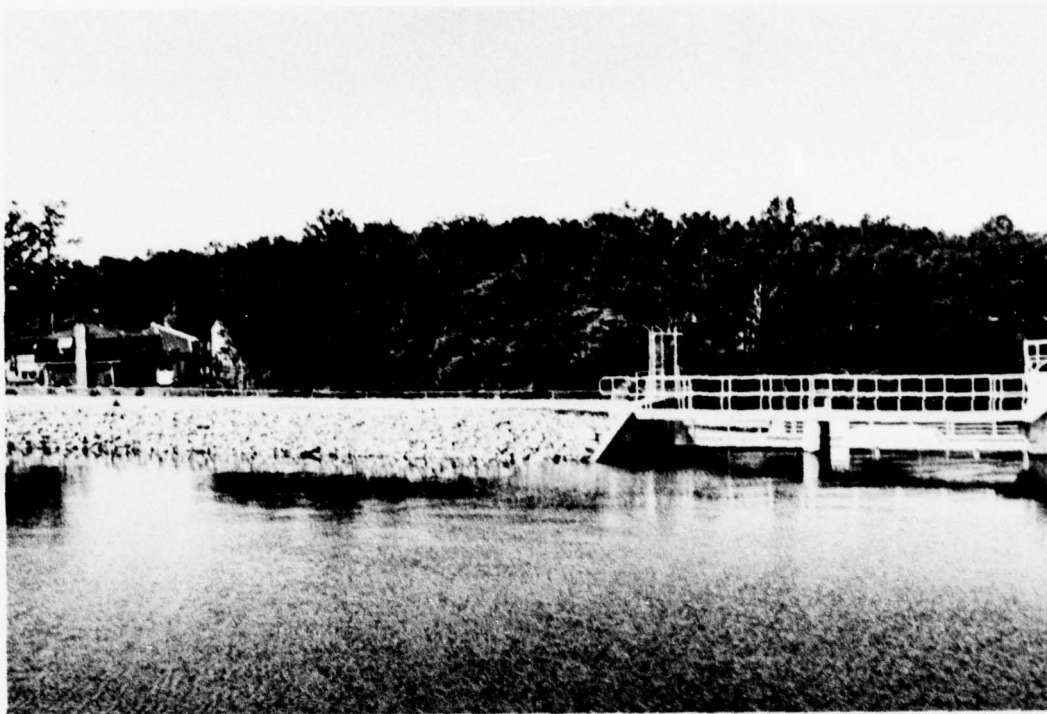
PHOTO 7

- 3) Riprap failures - due to wave action and/or vandalism - were noted on the upstream slope of the dam adjacent to both spillway inlet wing walls.

- Photo 7 - View Downstream (West) at Left (North) Side of
Spillway and Upstream Slope of Dam From Intake
Tower; Riprap Failure Left of Spillway (Close-up in
Photo 8); Gate Control Chamber at Right Edge of
Photo - 9 June 1978

- 2) Riprap damage on the upstream slope of the dam should be repaired during normal maintenance activities.
- 3) An emergency operations procedure should be developed and made known to all operations personnel. This should include instructions for dam operations during emergencies, evacuation notification for downstream areas, and plans for emergency drawdown of the reservoir.
- 4) Consideration should be given to provide a more positive method to lock the gates in the current operating position without dependency on the hydraulic system and the wooden blocks.

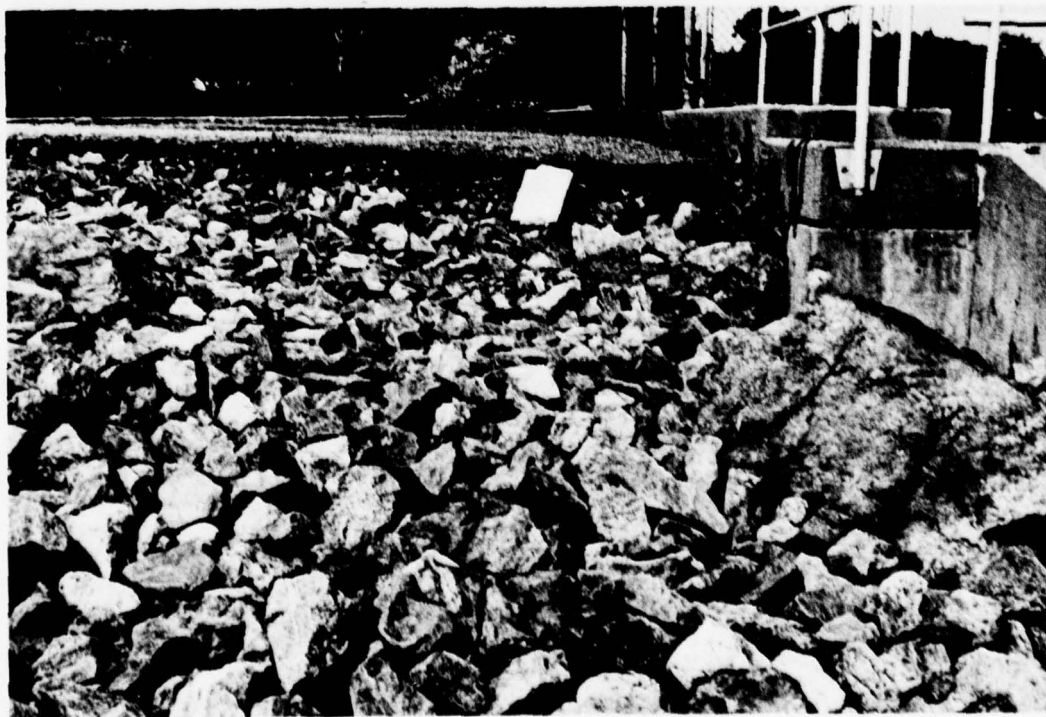
PHOTO 8

- Photo 8 - Close-up of Riprap Failure at Left Side of Spillway
(Center of Photo 7); Clipboard for Scale-9 June 1978
- Photo 9 - View Upstream (East) at Left (South) Side Spillway
Outlet Showing Wing Wall and Downstream Slope of
Dam; Area of Minor Erosion Right of Top of Wing Wall;
Seepage and Sand Boils (Close-up in Photo 10)
Between T.J. Dougan and Clipboard at Toe of Wing Wall -
9 June 1978

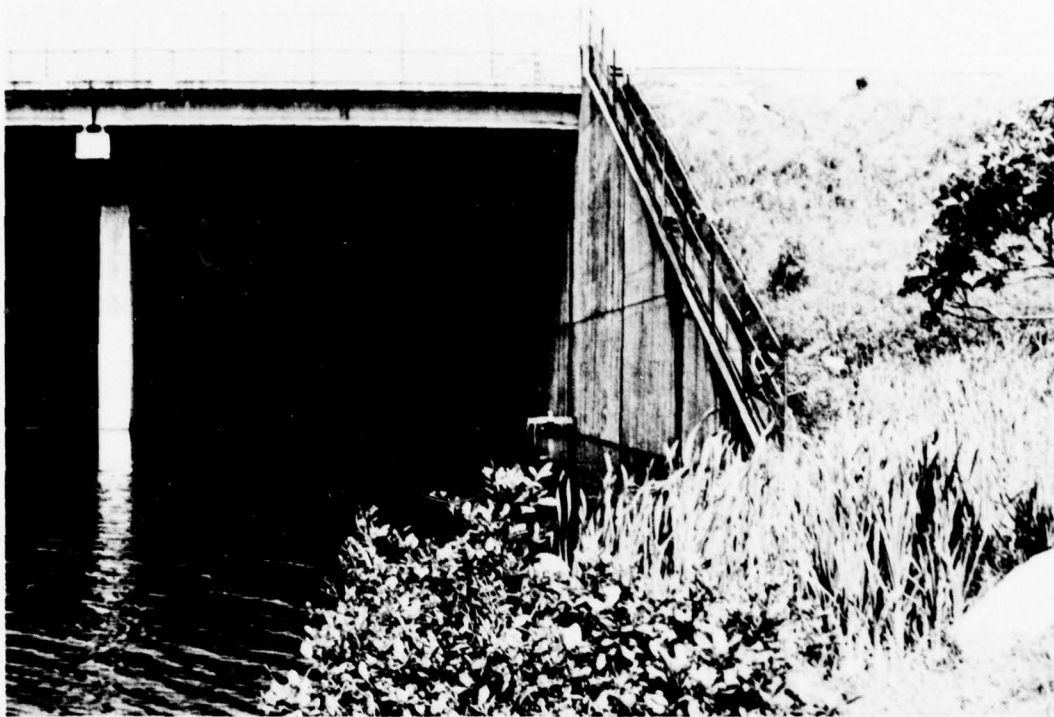
PHOTO 9

- b. Dam -
 - 1) Seepage and piping were observed at the downstream toe of the dam behind both spillway outlet wing walls on 9 June, as described in the supplement to the visual inspection check list in Appendix A. The seepage water was clear on 10 June, indicating that the piping had apparently stabilized. Seepage at the downstream toe of the dam probably indicates that the toe drain outlets, and perhaps also the toe drains themselves, are plugged.

- 1) The Passaic Valley Water Commission should locate, excavate and clean as necessary the toe drain outlets at the ends of the two spillway outlet wing walls. In addition, the Commission should consider installation of additional toe drain outlets above tailwater level. It is expected that the consultant recommended in Item 2) below would provide guidance in this matter.

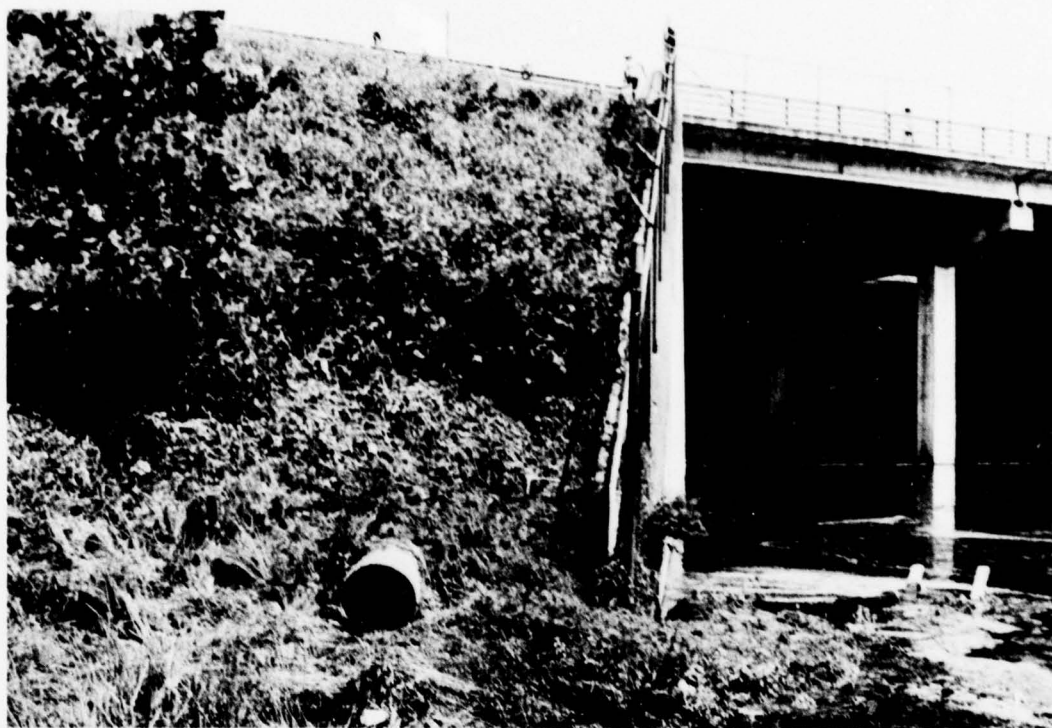
PHOTO 11

- Photo 11 - View Upstream (East) at Right (North) Side Spillway Outlet Showing Wing Wall and Downstream Slope of Dam; 18 Inch Corrugated Metal Pipe in Left Center; Piping Hole (Close-up in Photo 12) Left of Wing Wall Three Feet Above Tailwater at Folded Rule - 9 June 1978
- Photo 12 - Close-up of Piping Hole Encountered in Test Pit at Toe of North Spillway Outlet Wing Wall (Photo 11) - 9 June 1978
- Photo 13 - View Downstream (West) Over East End of Lionshead Lake From Downstream Slope of Point View Dam, Left (South) of Spillway; Ditch Carrying Storm Water and Stream Flow From Left Abutment Area Enters Lake at Left Edge of Photo - 9 June 1978
- Photo 14 - View Downstream (Northwest) Over East End of Lionshead Lake From Southwest Bank - 9 June 1978
